Chamberlain Innocence Committee

New Forensic Evidence

**An Inquiry Into the Convictions of
M. and L. Chamberlain**

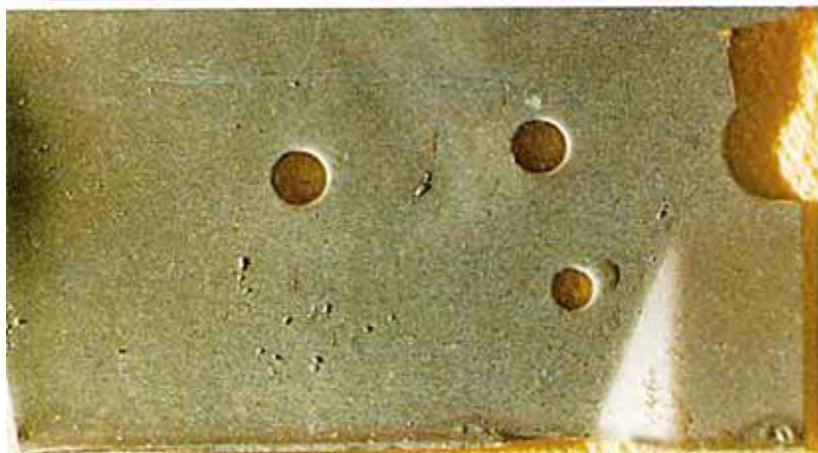
Photograph 2. (centre) Another bracket removed from a Holden Torana with a spray pattern similar to that seen on the Chamberlain bracket. Note the apparent source of this spray pattern and its location on the bracket. Compare this with the spray pattern on the Chamberlain bracket shown in Photograph 1, above.

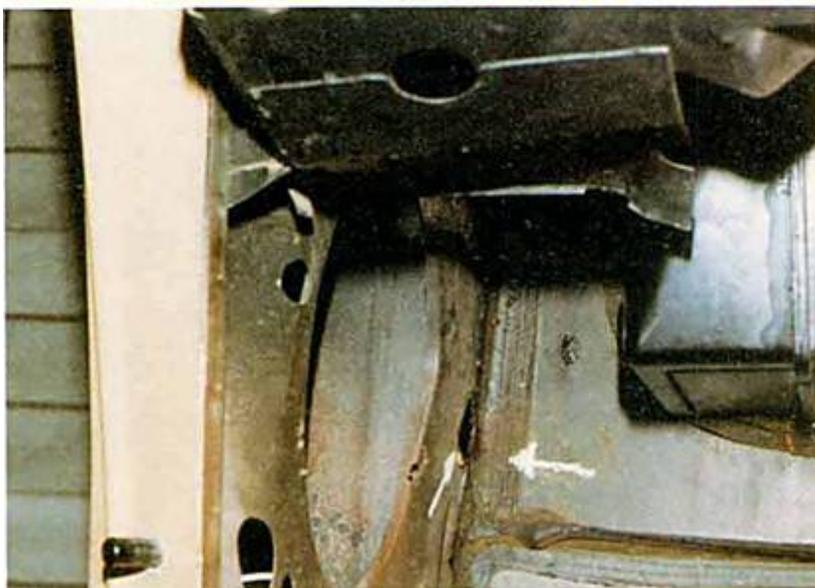
Photograph 3. (bottom) The position of the dash support bracket in the car. This view is taken from the passenger's seat looking toward the firewall. The passenger's door pillar can be seen on the left. The plenum drain hole.

By relating these measurements to the bodywork of a Holden Torana, the source of the spray was pin-pointed as a drain hole used to prevent water accumulating in the car's ventilation system. This drain hole, the plenum drain hole, opens into the wheel well of the car, and is arrowed in Photograph 3.

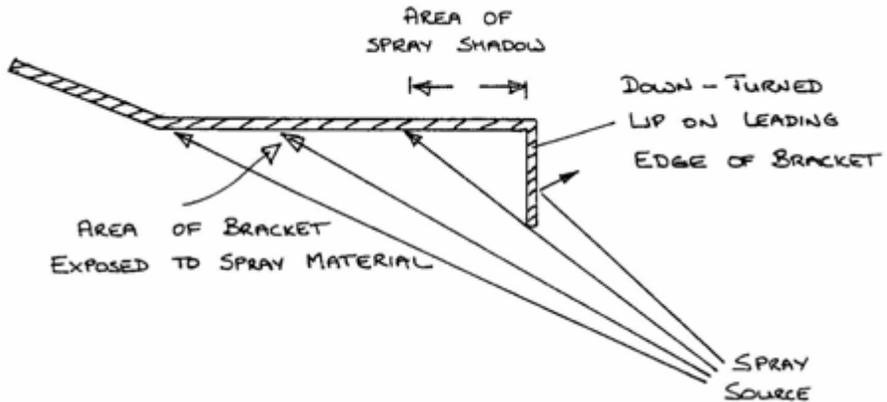
In common with all the other brackets these marks appeared to converge at a point about 200mm in front of the bracket. Calculations based on the geometry of the bracket and the position of the spray showed that the spray always hit the bracket at an angle of about twenty-two degrees. The basis of these calculations are shown in Figure 1 below.

Figure 1. A side view of the dash support bracket, showing how the down-turned lip on the leading edge of the bracket protected the area close behind it from spray material. This protected area is referred to as a "spray shadow". The angle at which the spray hit the bracket can be calculated using trigonometry, given the height of the lip and the width of the "shadow".

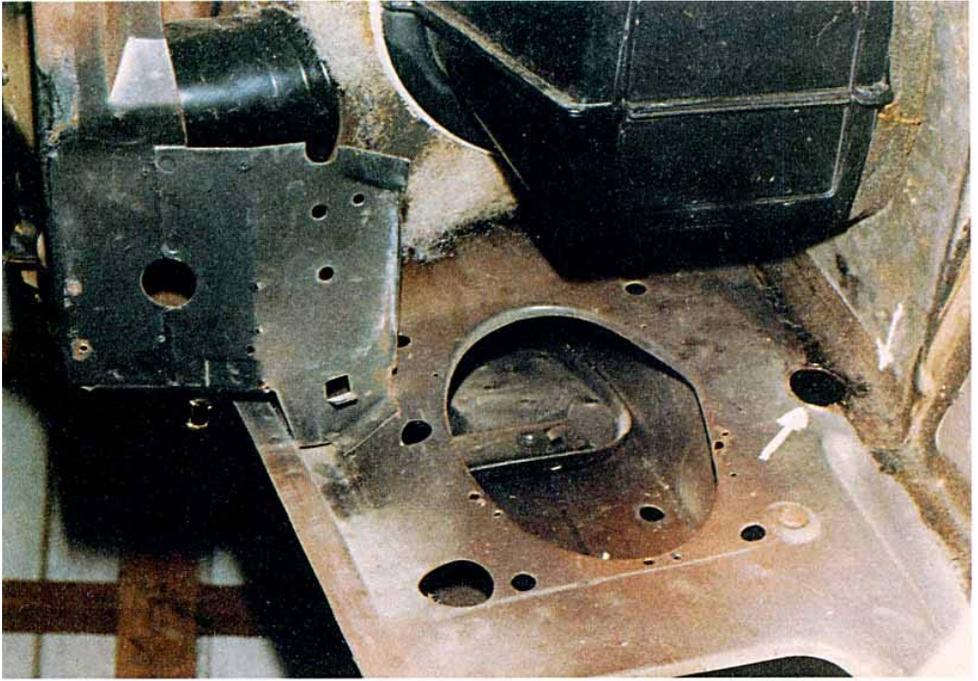
Photograph 4 (top) A worm's eye view of a dash support bracket looking up through the floor of the car. This photograph allows details obscured in the photograph below to be easily seen.

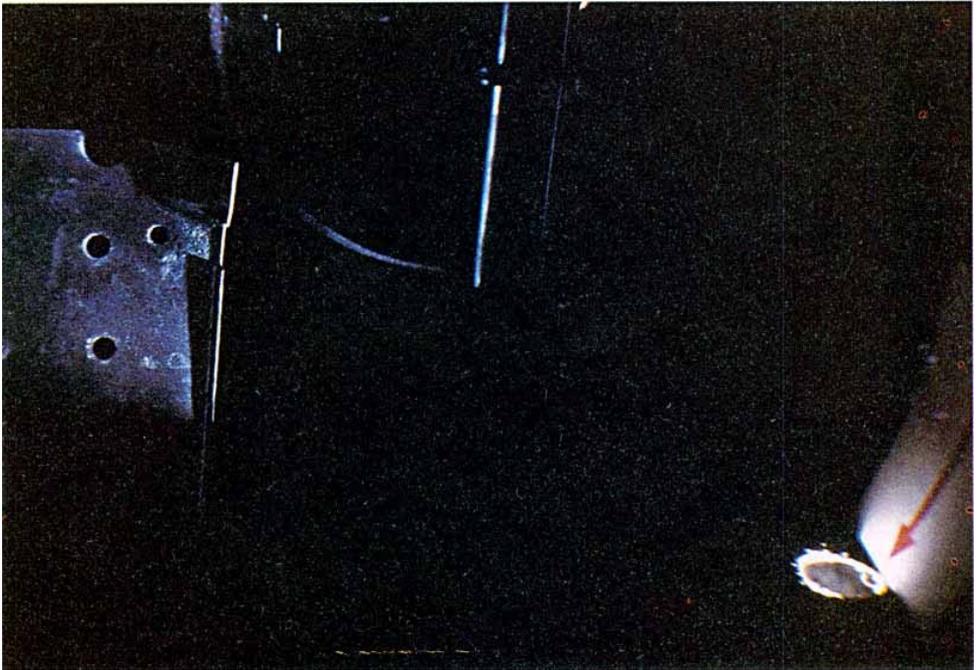
To test the theory that the spray material passed through the plenum drain hole's light beam was shone through this hole onto the dash support bracket. The idea behind this test was simple. Both light and sprayed material travel in a straight line. Therefore the spray material should only be found on the illuminated part of the bracket. By comparing the position of the spray material on the Chamberlain bracket in Photograph 1 with the illuminated area of the bracket in Photograph 5, it is clear that the material on the Chamberlain bracket passed through the plenum drain hole.

Photograph 5 (bottom) A dash support bracket illuminated through the plenum drain hole. Material sprayed through this hole should be found on the illuminated part of the bracket. Compare the illuminated area on this bracket with the area covered by the spray on the Chamberlain bracket.

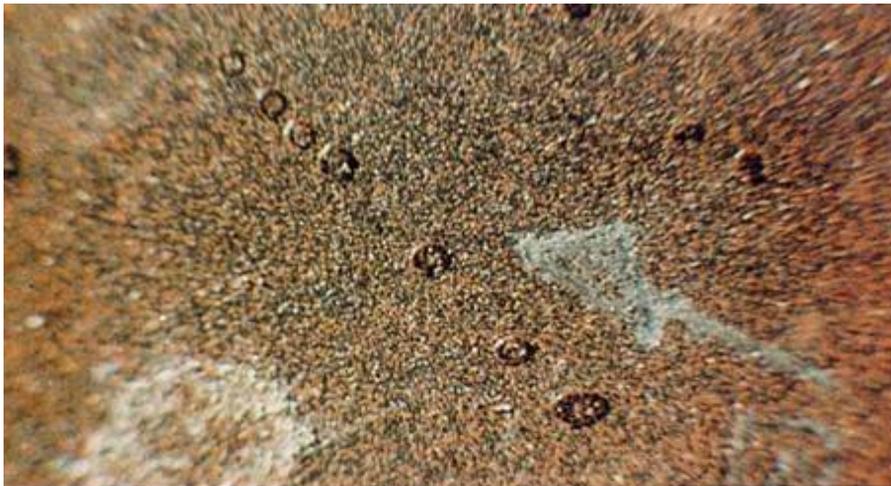
Photograph 6. (top) The appearance of blood which has been sprayed onto a dash support bracket. Note the low profile and raised rim of each of these blood-spots. Compare the appearance of these stains with the material on the Chamberlain bracket, shown below.

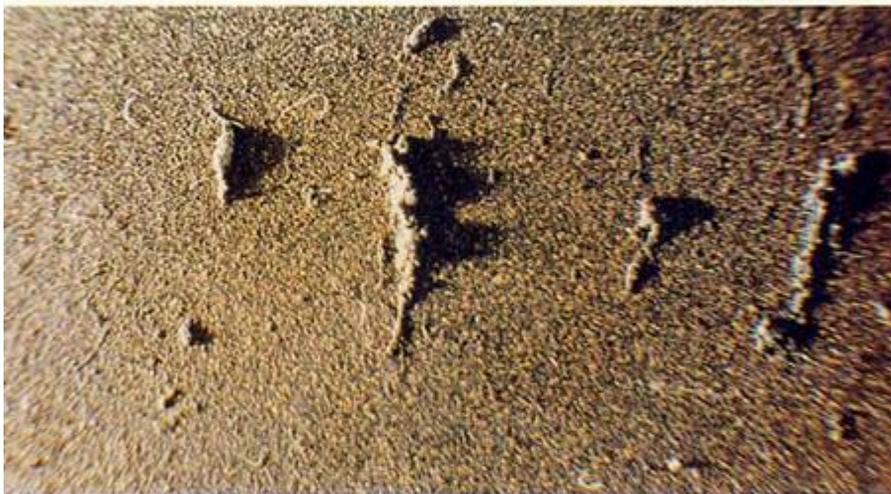
Photograph 7. (centre) The appearance of spray material on the Chamberlain dash support bracket. The rugged profile of this spray material is typical of the appearance of Dufix seen on other dash support brackets.

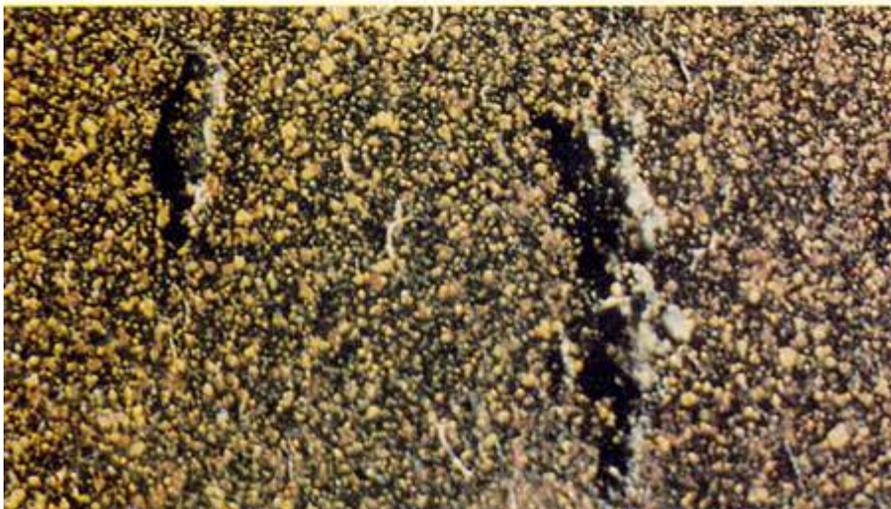
A completely independent observation establishes when the spray material was put on the bracket. In Photograph 8, yellow flecks of paint overspray can be seen uniformly distributed on the bracket itself and also on the Dufix spray material. This paint overspray, which is found on all brackets, was deposited during the assembly process at GMH. Thus the spray pattern must have been deposited on the bracket prior to the painting of the car at the time of its manufacture.

Photograph 8. (bottom) Two spray marks from the Chamberlain bracket, seen at the left in Photograph 7, have been enlarged here to show yellow flecks of paint overspray both on the surface of the bracket and also on the spray material itself. This dates the deposition of the spray prior to the time when the car was painted during assembly by GMH.

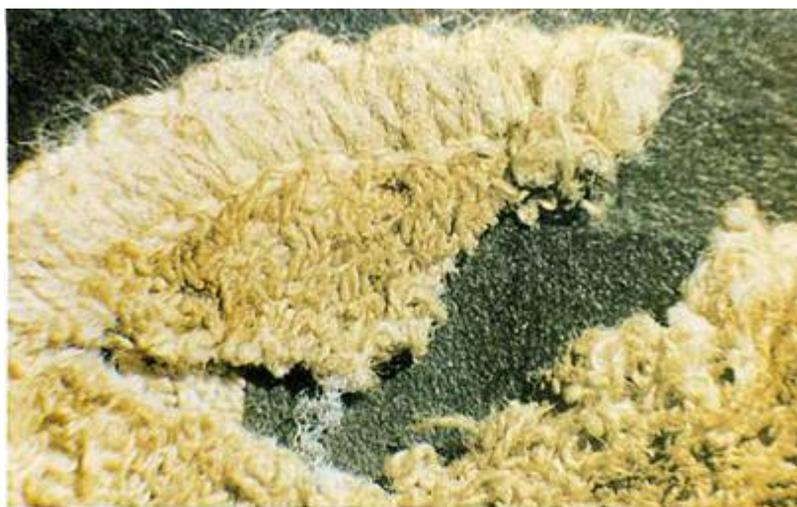
Photograph 1. (top) A partial view of the damaged left sleeve in A Chamberlain's jumpsuit. At the top, centre left and centre right, note the arcs of damage which are comparable in size and shape to the canine central incisor damage shown in Photograph 13.

(i) Single or repeated arcs of damage, attributable to the action of the canine's central incisor teeth are seen in Photograph 13. The arcs measure about 10mm across the cord of arc. It is common to see "tails" of fabric between adjacent crescents. Compare these with arcs of damage in the Chamberlain Jumpsuit (Photograph 1).

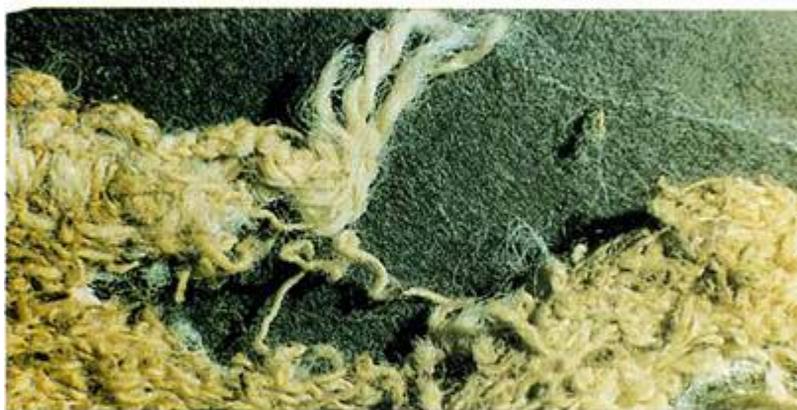
Photograph 2. A partial view of the damaged sleeve of A Chamberlain's jumpsuit. The circumference of the damage seen here is about 100mm. It is formed from about 10 small cuts joined end to end. These small cuts range in length from about 8mm up to 15mm. Compare the size and appearance of these cuts with known canine cuts, shown in Photograph 12.

(v) Cotton threads extending beyond the severance line by up to several cm are common in canine damaged samples, but are produced with scissors only by deliberate manipulation (compare Photographs 2 and 16).

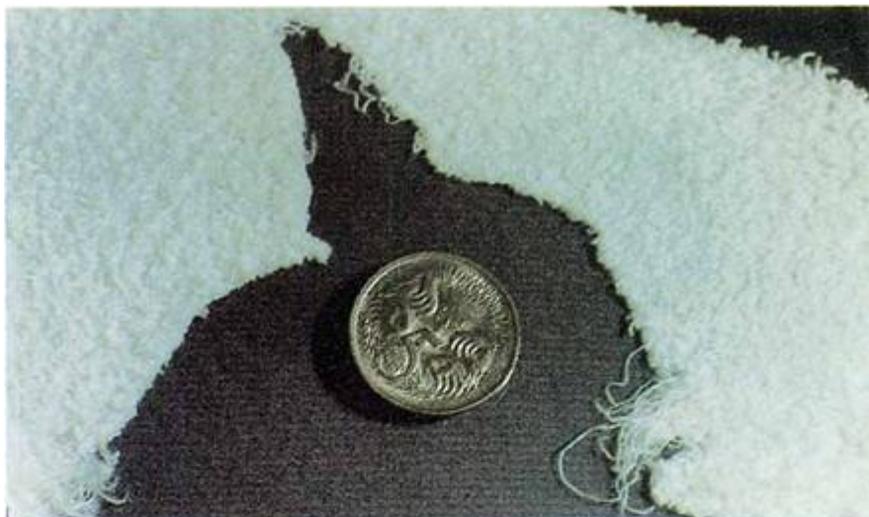
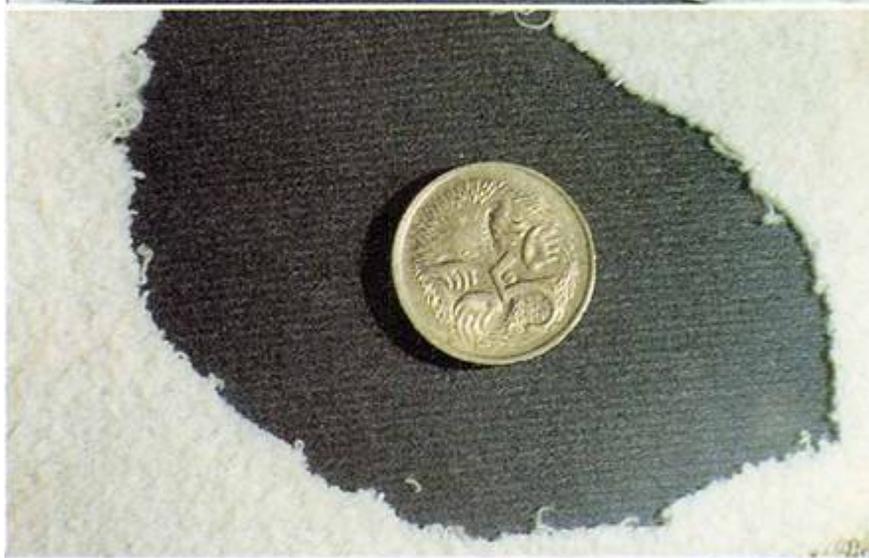
Sgt F B Cocks (of the South Australian Police Technical Services Section) used an intricate series of cuts to simulate the damage to the Chamberlain jumpsuit. The appearance of this damage is shown in Photographs 6, 7 and 8. We use the sample he produced in demonstrating this technique to the court as the control for scissor damage.

Photograph 6 (top) and Photograph 7. (centre) Scissor cuts in the arm of a test jumpsuit. These were produced in the courtroom by Sgt Cocks, to demonstrate how the Crown believed the damage in the Chamberlain jumpsuit had been caused.

No corresponding arcs of damage can be seen in the jumpsuit which was damaged with scissors by Sgt F B Cocks (Photographs 6 - 8).

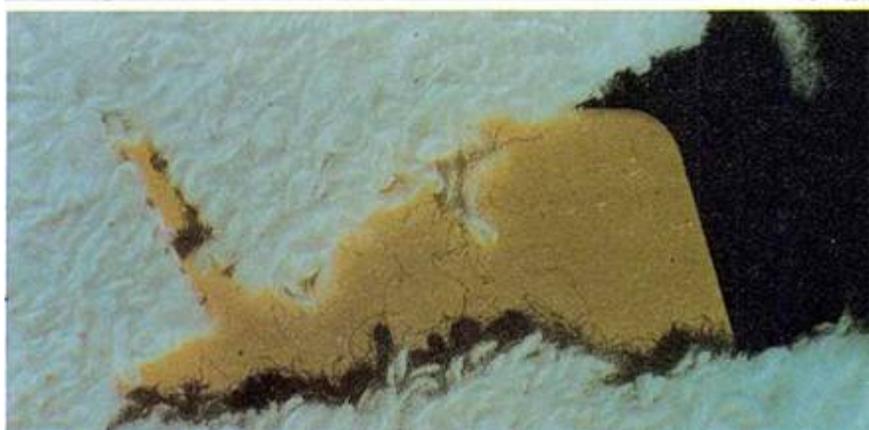
Photograph 8. (bottom) The cut shown here in the collar of a test jumpsuit, was produced in the courtroom by Sgt Cocks to demonstrate how the Crown believed the collar cut in the Chamberlain jumpsuit had been made.

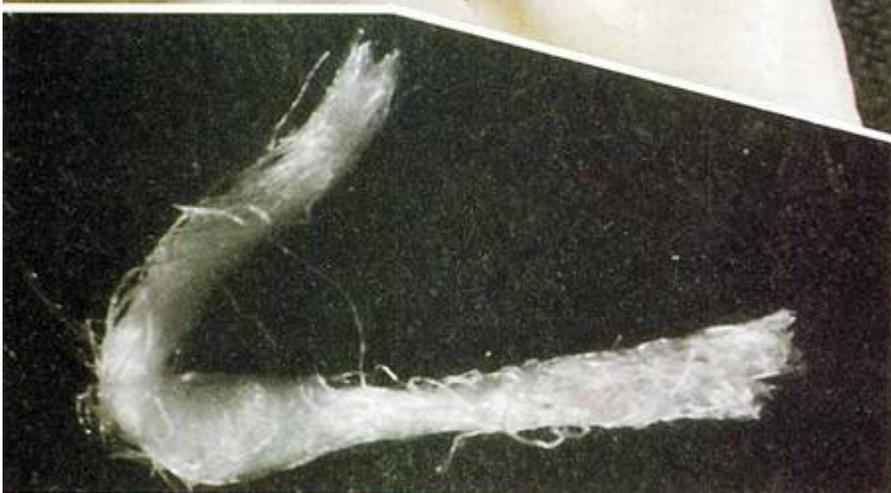
Photograph 10. A cotton tuft, produced when the pile in Bonds towelling fabric is cut with a sharp instrument. At the trial the court was told that the presence of these tufts constituted the strongest possible evidence that A Chamberlain's jumpsuit had been cut with scissors. It was not possible - the court was told - for dingo teeth to produce tufts such as these. The tufts shown in this photograph were produced by the action of canine teeth.

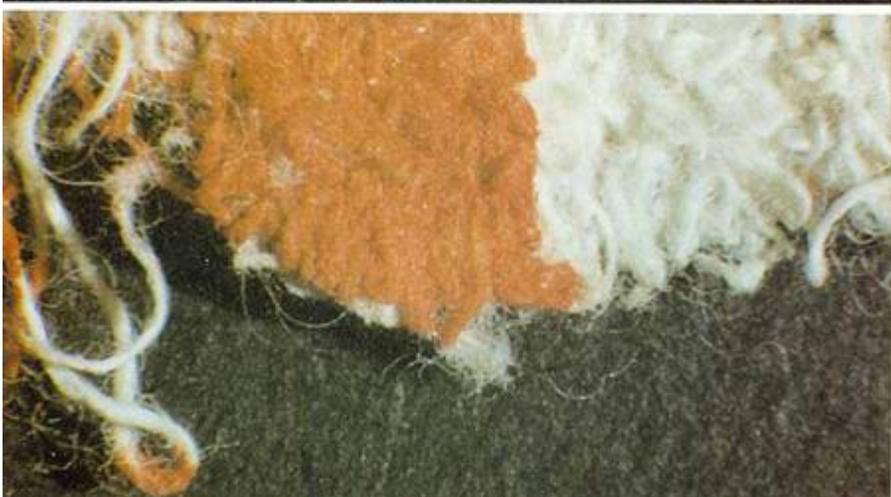
Photograph 11. (bottom) The appearance of a group of threads seen in a sample of canine damaged fabric illustrates the cutting ability of canine teeth.

(ii) Thread ends where all the constituent fibres end in a plane occur in canine damage with a frequency similar to that in the Chamberlain jumpsuit (see Photograph 11).

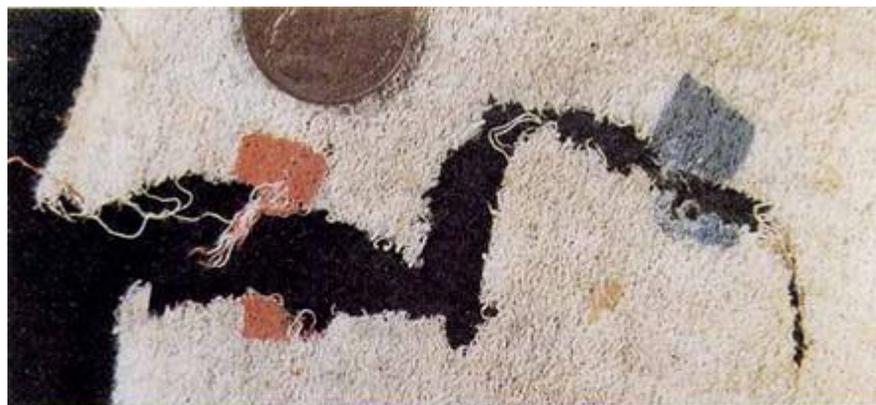
Photograph 12. (top) The damage seen in this photograph illustrates a number of typical canine damage features found in A Chamberlain's jumpsuit. The zig-zag cut, about 100mm long, is formed from a series of smaller cuts, each about 12mm long, joined end to end. The cut in the sleeve of the Chamberlain jumpsuit (Photograph 2) is likewise formed from a series of 12mm cuts.

Abrupt changes in the direction of cut, such as seen in the zig-zag here are found in canine damage patterns. Compare this with the abrupt change in direction of the V cut in the Chamberlain jumpsuit collar, shown in Photograph 3.

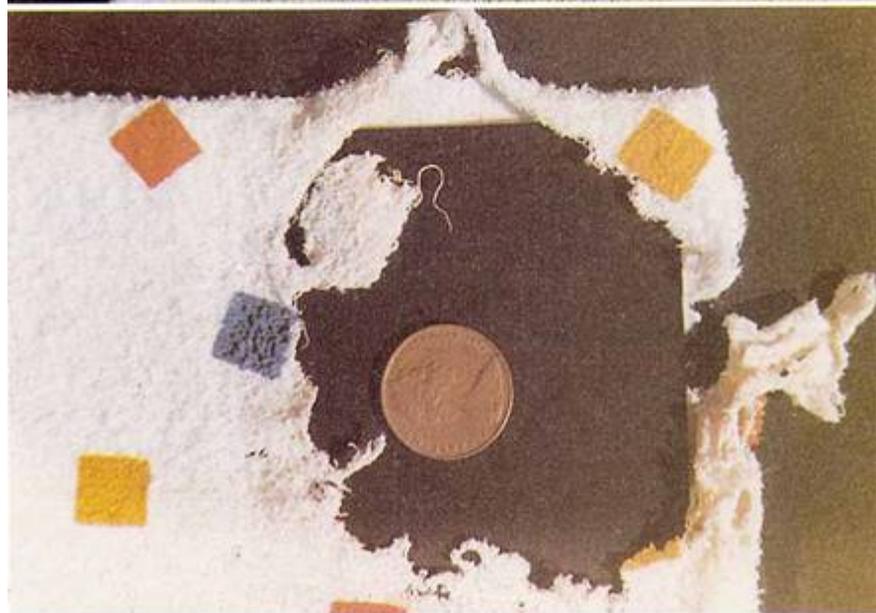
Photograph 13. (centre) The repeated arcs of damage in this fabric sample (lower left) show the damage resulting from the use of a dog's central incisors in an action reminiscent of a dog hunting fleas.

(v) Symmetrical patterns of damage were found in many canine samples. Holes about 70mm in diameter were often made to gain access to the food. See Photograph 13.

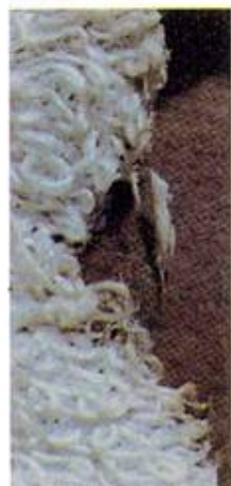
Photograph 14. (bottom left) The tuft shown in this photograph of canine damaged fabric is still attached to the main body of cloth by one or two fibres. Semi-detached tufts such as these are caused by small irregularities in the animal's teeth, but do not usually result from the action of scissors. A comparable tuft in the Chamberlain jumpsuit can be seen in Photograph 4.

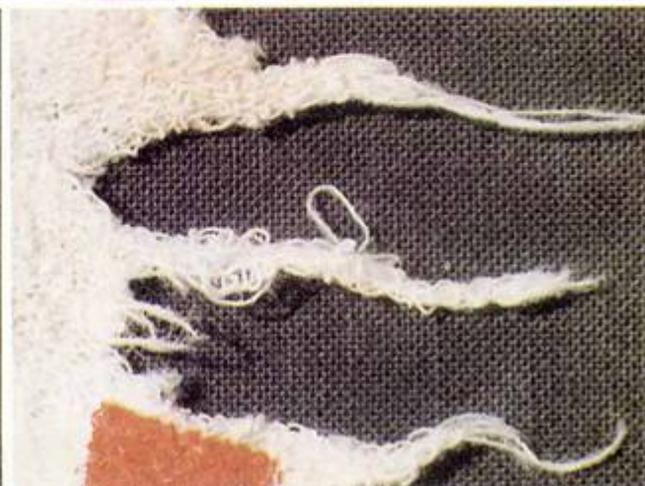
Photograph 15. (bottom right) The tails of fabric shown here were created when a dog secured the fabric with a paw, grasped the other end of the cloth between her central incisors and raised her head (cf Photograph 5).

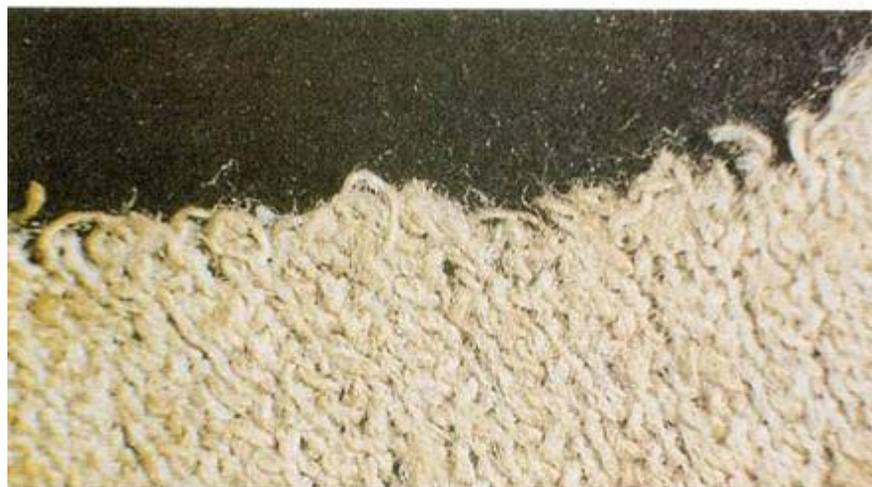
Photograph 17. (centre) The appearance of the cut fabric edge in A Chamberlain's jumpsuit.

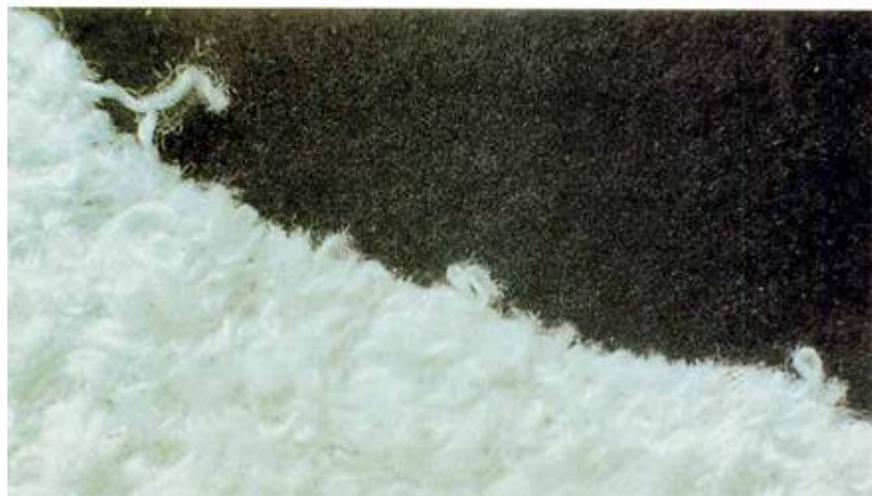
Photograph 18. (bottom) The appearance of a scissor cut edge of fabric.

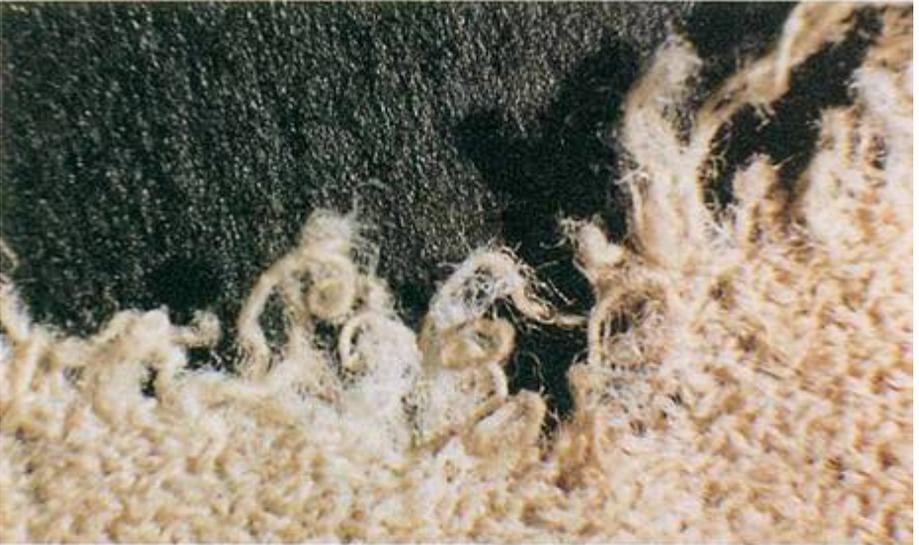
Photograph 20. The appearance of the damage line in the sleeve of the Chamberlain jumpsuit.

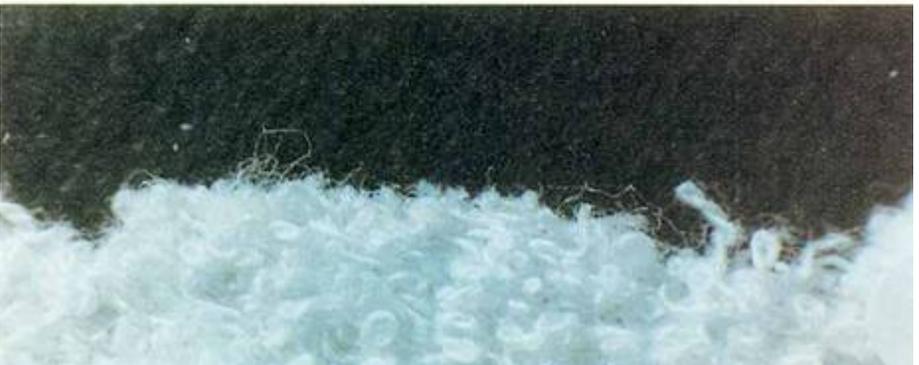
Photograph 21. The typical appearance of fabric cut by scissors. This damage seen here is from the jumpsuit cut by Sgt Cocks.

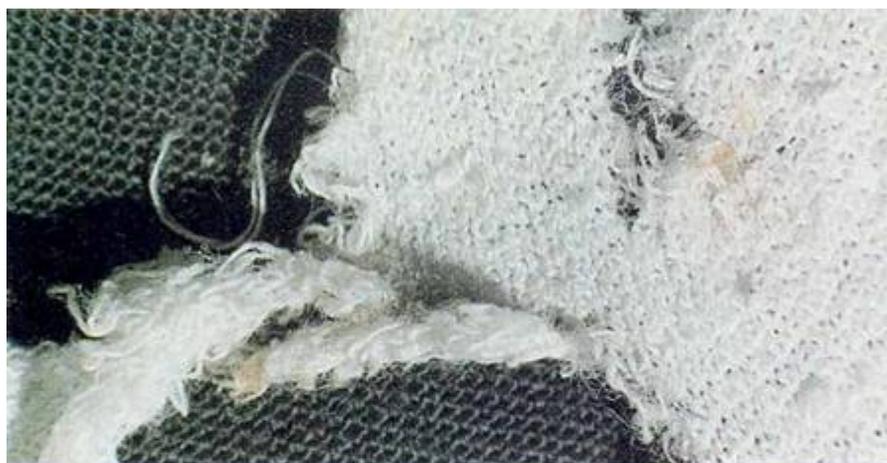
Photograph 22. (top) The damage seen here typically occurs when two cuts made in the fabric by a canine have not met and the animal has mauled the intervening fabric. Note the curled edge of the material, and the general matting of the threads where the two cuts come together.

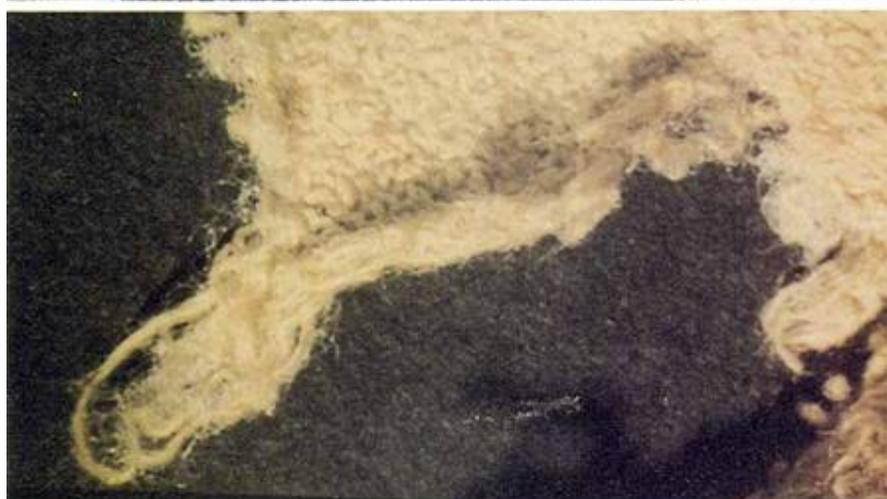
Photograph 23. (centre) The damage shown here is an enlargement of the cloth tail seen in the Chamberlain jumpsuit sleeve, Photograph 1, centre right. The appearance of this damage should be compared with that seen above.

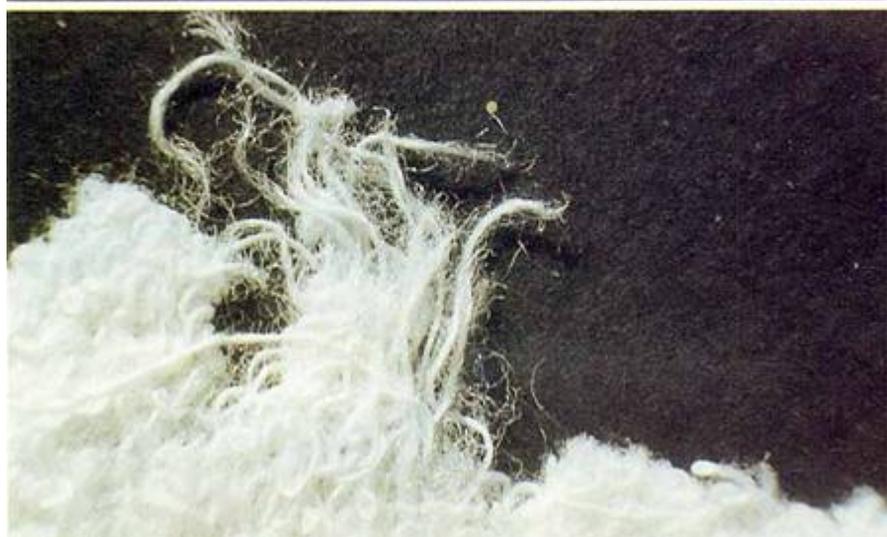
Photograph 24. (bottom) This damage, from the Cocks jumpsuit occurred when two scissor cuts did not meet and the intervening fabric was torn apart. Compare this with the damage seen in both photographs above.

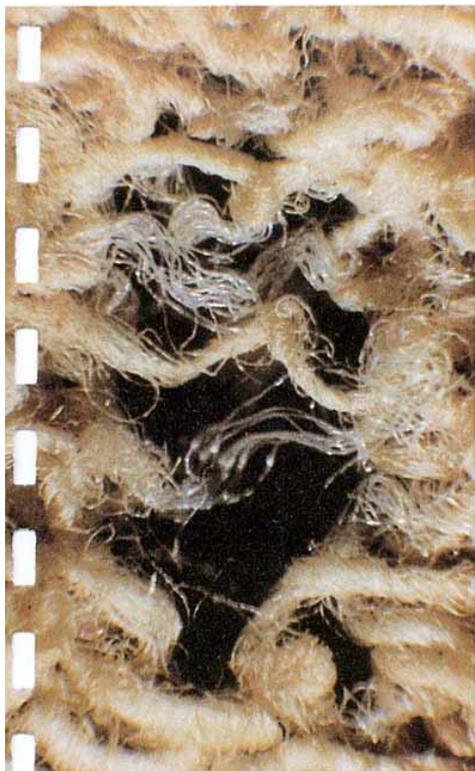
Photograph 25. (top left) A number of small isolated holes were found in the centre back of A Chamberlain's jumpsuit. The court was told that if holes such as the one shown here had been caused by a dog they could not occur in isolation from other holes or damage.

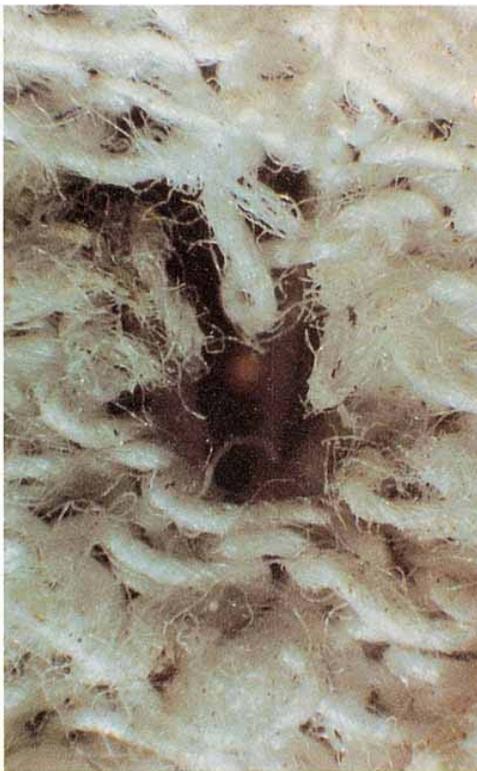
Photograph 26. (top right) One of a number of isolated holes found in canine damaged fabric.

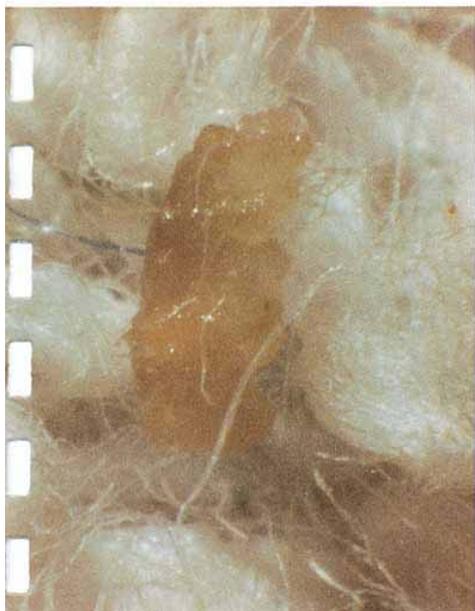
Photograph 28. (bottom left) Small fragment of material seen in the left arm of the Chamberlain jumpsuit.

These fragments should be compared with meat fragments embedded in the fabric by the animal's teeth in Photograph 27.
