Chamberlain Innocence Committee

New Forensic Evidence

**An Inquiry Into the Convictions of
M. and L. Chamberlain**

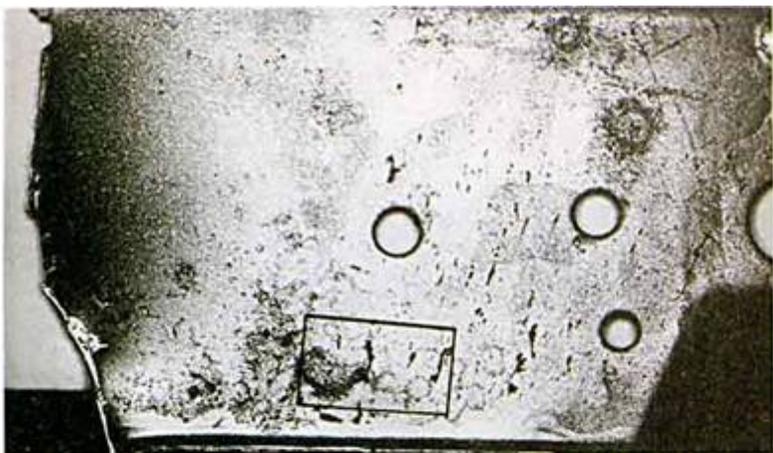
Photograph 2. (centre) Another bracket removed from a Holden Torana with a spray pattern similar to that seen on the Chamberlain bracket. Note the apparent source of this spray pattern and its location on the bracket. Compare this with the spray pattern on the Chamberlain bracket shown in Photograph 1, above.

Photograph 3. (bottom) The position of the dash support bracket in the car. This view is taken from the passenger's seat looking toward the firewall. The passenger's door pillar can be seen on the left. The plenum drain hole.

By relating these measurements to the bodywork of a Holden Torana, the source of the spray was pin-pointed as a drain hole used to prevent water accumulating in the car's ventilation system. This drain hole, the plenum drain hole, opens into the wheel well of the car, and is arrowed in Photograph 3.

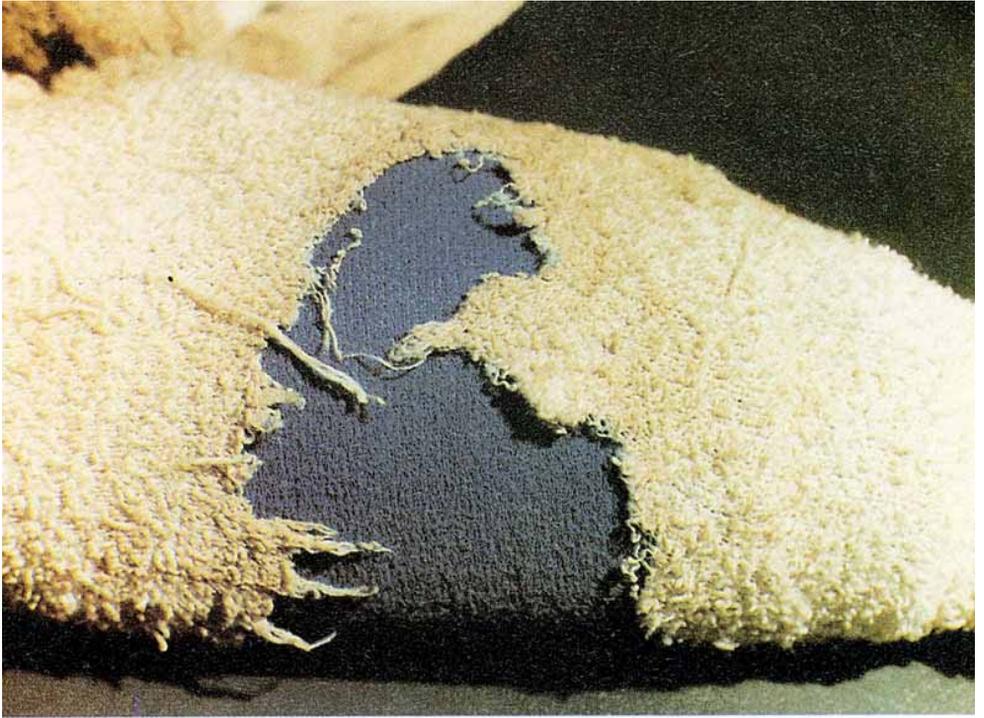
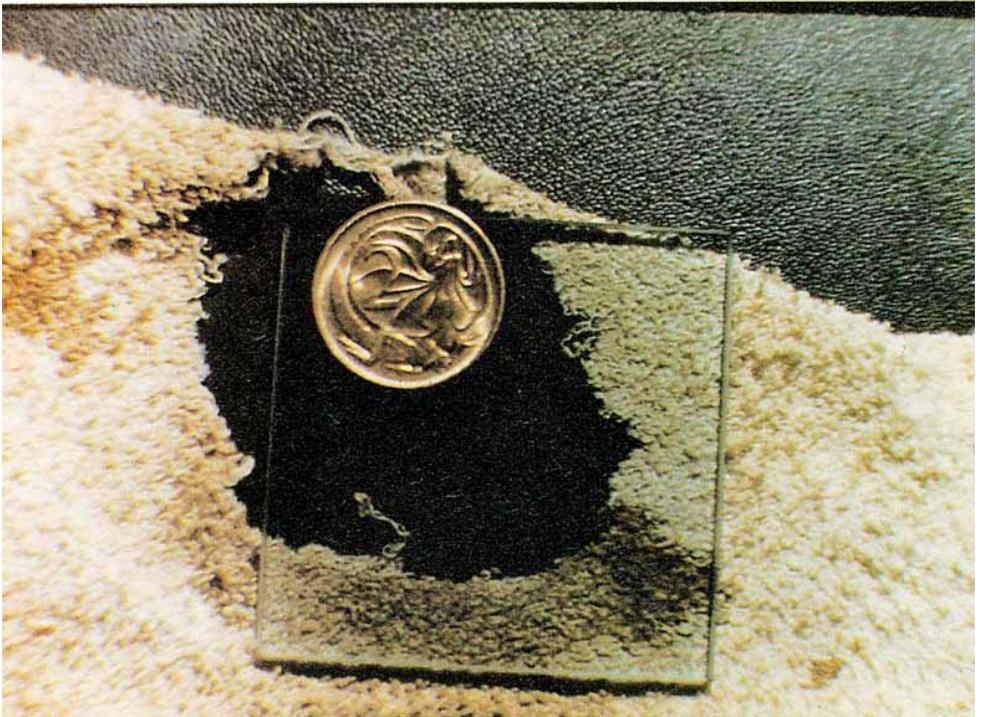
When A Chamberlain vanished from the family tent at Ayers Rock in August 1980 her parents claimed that she had been taken by a dingo. One week later her damaged clothing was recovered and submitted for scientific examination. The damage was mainly confined to the sleeve and collar of the jumpsuit. Photographs 1 to 4 show this damage.

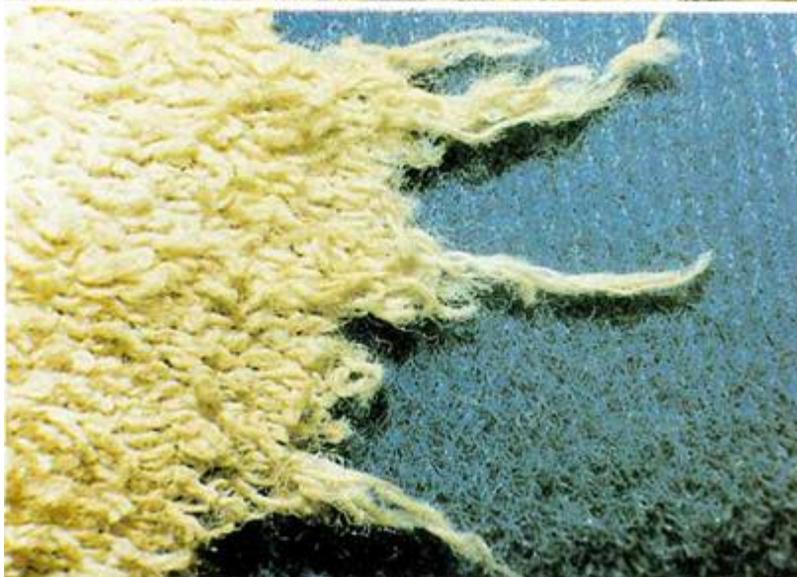
Photograph 1. (top) A partial view of the damaged left sleeve in A Chamberlain's jumpsuit. At the top, centre left and centre right, note the arcs of damage which are comparable in size and shape to the canine central incisor damage shown in Photograph 13.

Photograph 2. A partial view of the damaged sleeve of A Chamberlain's jumpsuit. The circumference of the damage seen here is about 100mm. It is formed from about 10 small cuts joined end to end. These small cuts range in length from about 8mm up to 15mm. Compare the size and appearance of these cuts with known canine cuts, shown in Photograph 12.

(i) Single or repeated arcs of damage, attributable to the action of the canine's central incisor teeth are seen in Photograph 13. The arcs measure about 10mm across the cord of arc. It is common to see "tails" of fabric between adjacent crescents. Compare these with arcs of damage in the Chamberlain Jumpsuit (Photograph 1).

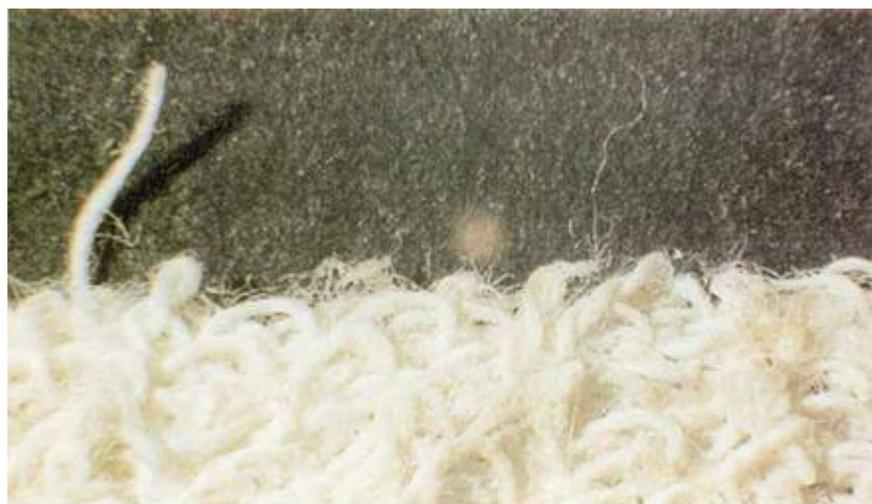
Photograph 17. (centre) The appearance of the cut fabric edge in A Chamberlain's jumpsuit.

Photograph 18. (bottom) The appearance of a scissor cut edge of fabric.

Compare the quality of the cut edge from the Chamberlain jumpsuit with the canine cut and scissor cut in Photographs 17, 16 and 18 respectively.

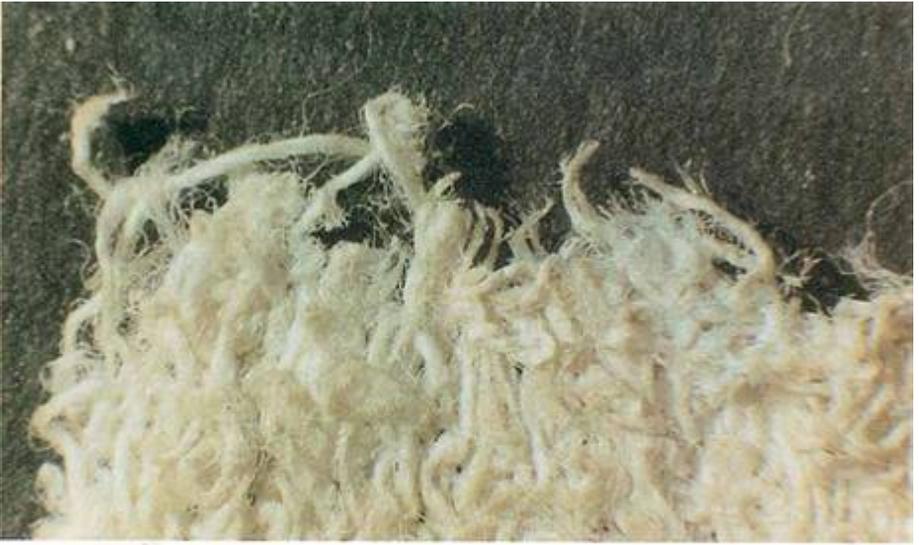
(iv) Irregularities in the severance line such as those shown in Photographs 19 & 20 are characteristic of canine damage. Contrast this with the scissor damage lines in Photograph 21.

(vi) Stretched (frizzy) nylon threads along severance lines indicate the cloth has been subjected to significant stretching forces. Compare Photographs 19, 20 and 21. In some examples of canine damage such thread ends join the two sides of a cut. Photograph 3 shows such a thread in the collar of A Chamberlain's jumpsuit.

Photograph 21. The typical appearance of fabric cut by scissors. This damage seen here is from the jumpsuit cut by Sgt Cocks.

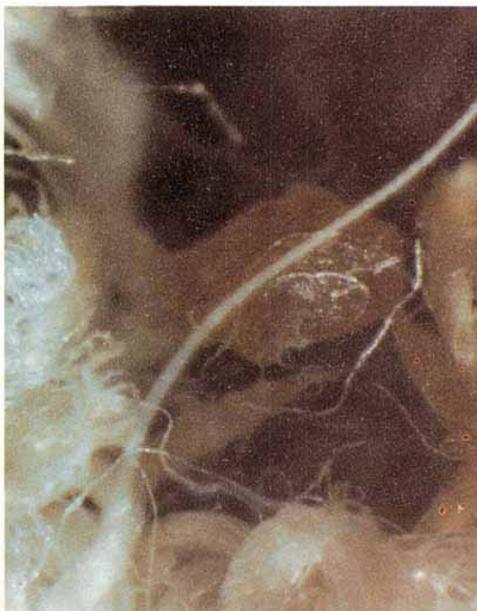
(x) Tissue or meat fragments. During microscopic examination of canine damaged samples and the Chamberlain jumpsuit, fragments of material such as those seen in Photographs 27 and 28 were noted. In the canine damaged samples the material is meat fragments.

Photograph 25. (top left) A number of small isolated holes were found in the centre back of A Chamberlain's jumpsuit. The court was told that if holes such as the one shown here had been caused by a dog they could not occur in isolation from other holes or damage.

Photograph 27. (bottom right) A meat fragment embedded in the fabric by the animal's teeth.

Photograph 28. (bottom left) Small fragment of material seen in the left arm of the Chamberlain jumpsuit.

These fragments should be compared with meat fragments embedded in the fabric by the animal's teeth in Photograph 27.
